To: sarah[sarah.jacobson@co.laplata.co.us]; Hakanson, Susan[susan.hakanson@co.laplata.co.us]; Knowlton, Butch[butch.knowlton@co.laplata.co.us]; Tommymoto McNamara [Personal Email/Ex. 6@gmail.com]; joe[joe.gabbard@co.laplata.co.us]; LPC Spina, Media[spinajm@co.laplata.co.us]; sean.smith@co.laplata.co.us]; frank[frank.sandoval@co.laplata.co.us]; Hitti, Media, SO[todd.hitti@co.laplata.co.us]; Downs, Media, SO[pat.downs@co.laplata.co.us]; jean.aldrich@state.co.us[jean.aldrich@state.co.us]; jeannine.natterman@state.co.us[jeannine.natterman@state.co.us]; Powell, Greg[Powell.Greg@epa.gov]; Smith, Paula[Smith.Paula@epa.gov]; Peterson, Cynthia[Peterson.Cynthia@epa.gov]; joe.lewandowski@state.co.us[joe.lewandowski@state.co.us]; jud@animasriverwetlands.com[jud@animasriverwetlands.com]
From: Dan Bender
Sent: Thur 8/13/2015 7:27:21 AM
Subject: Consolidated Ditch Test 8-12-15

Photos showing test on 8-12-15 of section of irrigation ditch owned by Consolidated Ditch Company, 12 miles north of Durango. Head gate was closed prior to main plume reaching the ditch. However, there was still some leakage since gate does not close water tight. Over approx 5 or 6 days, Animas River water ran passed head

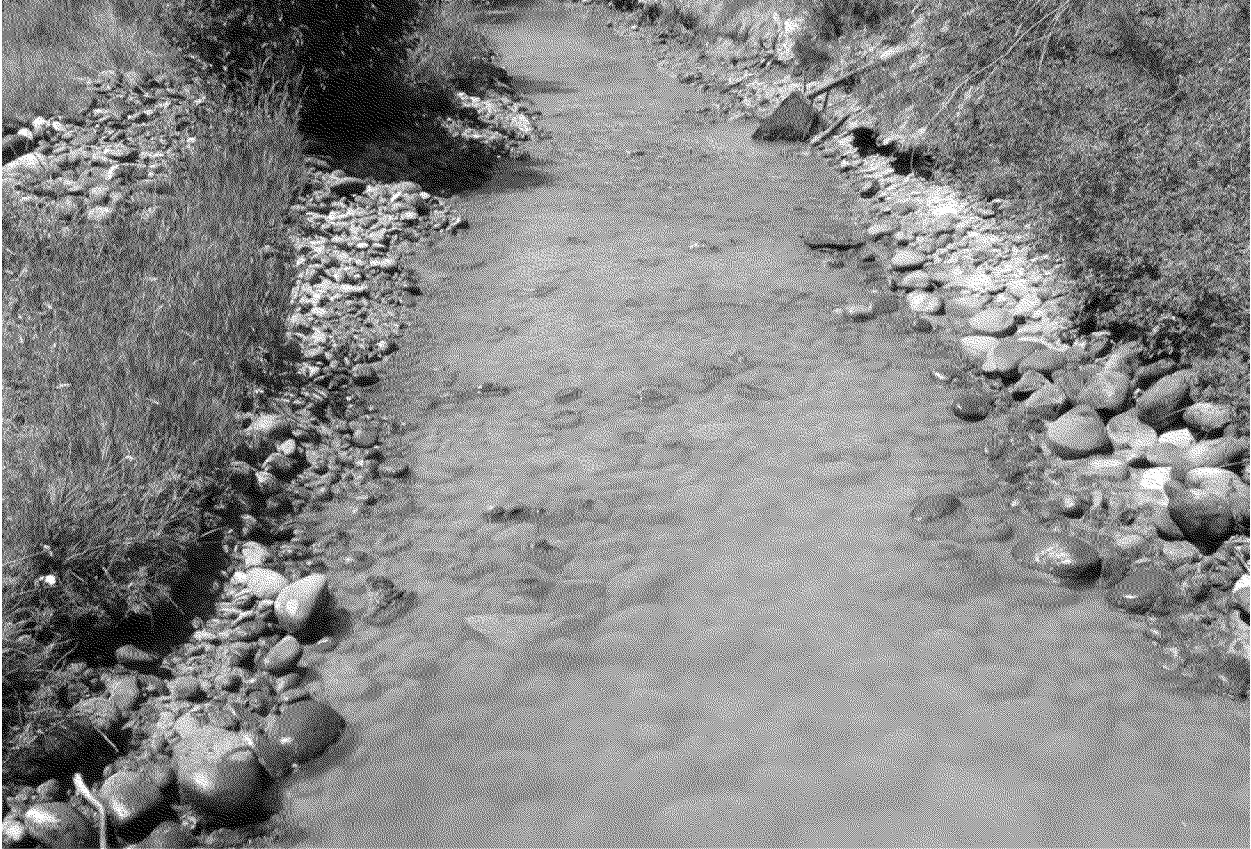
8-12-15 view looking south from the Consolidated Ditch Company irrigation head gate, 12 miles north of Durango. Photo taken 5 minutes after the head gate was closed.
